**Lower Duwamish Waterway
RM 4.3-4.9 East (Boeing Developmental Center)**

Historical Aerial Photograph Review

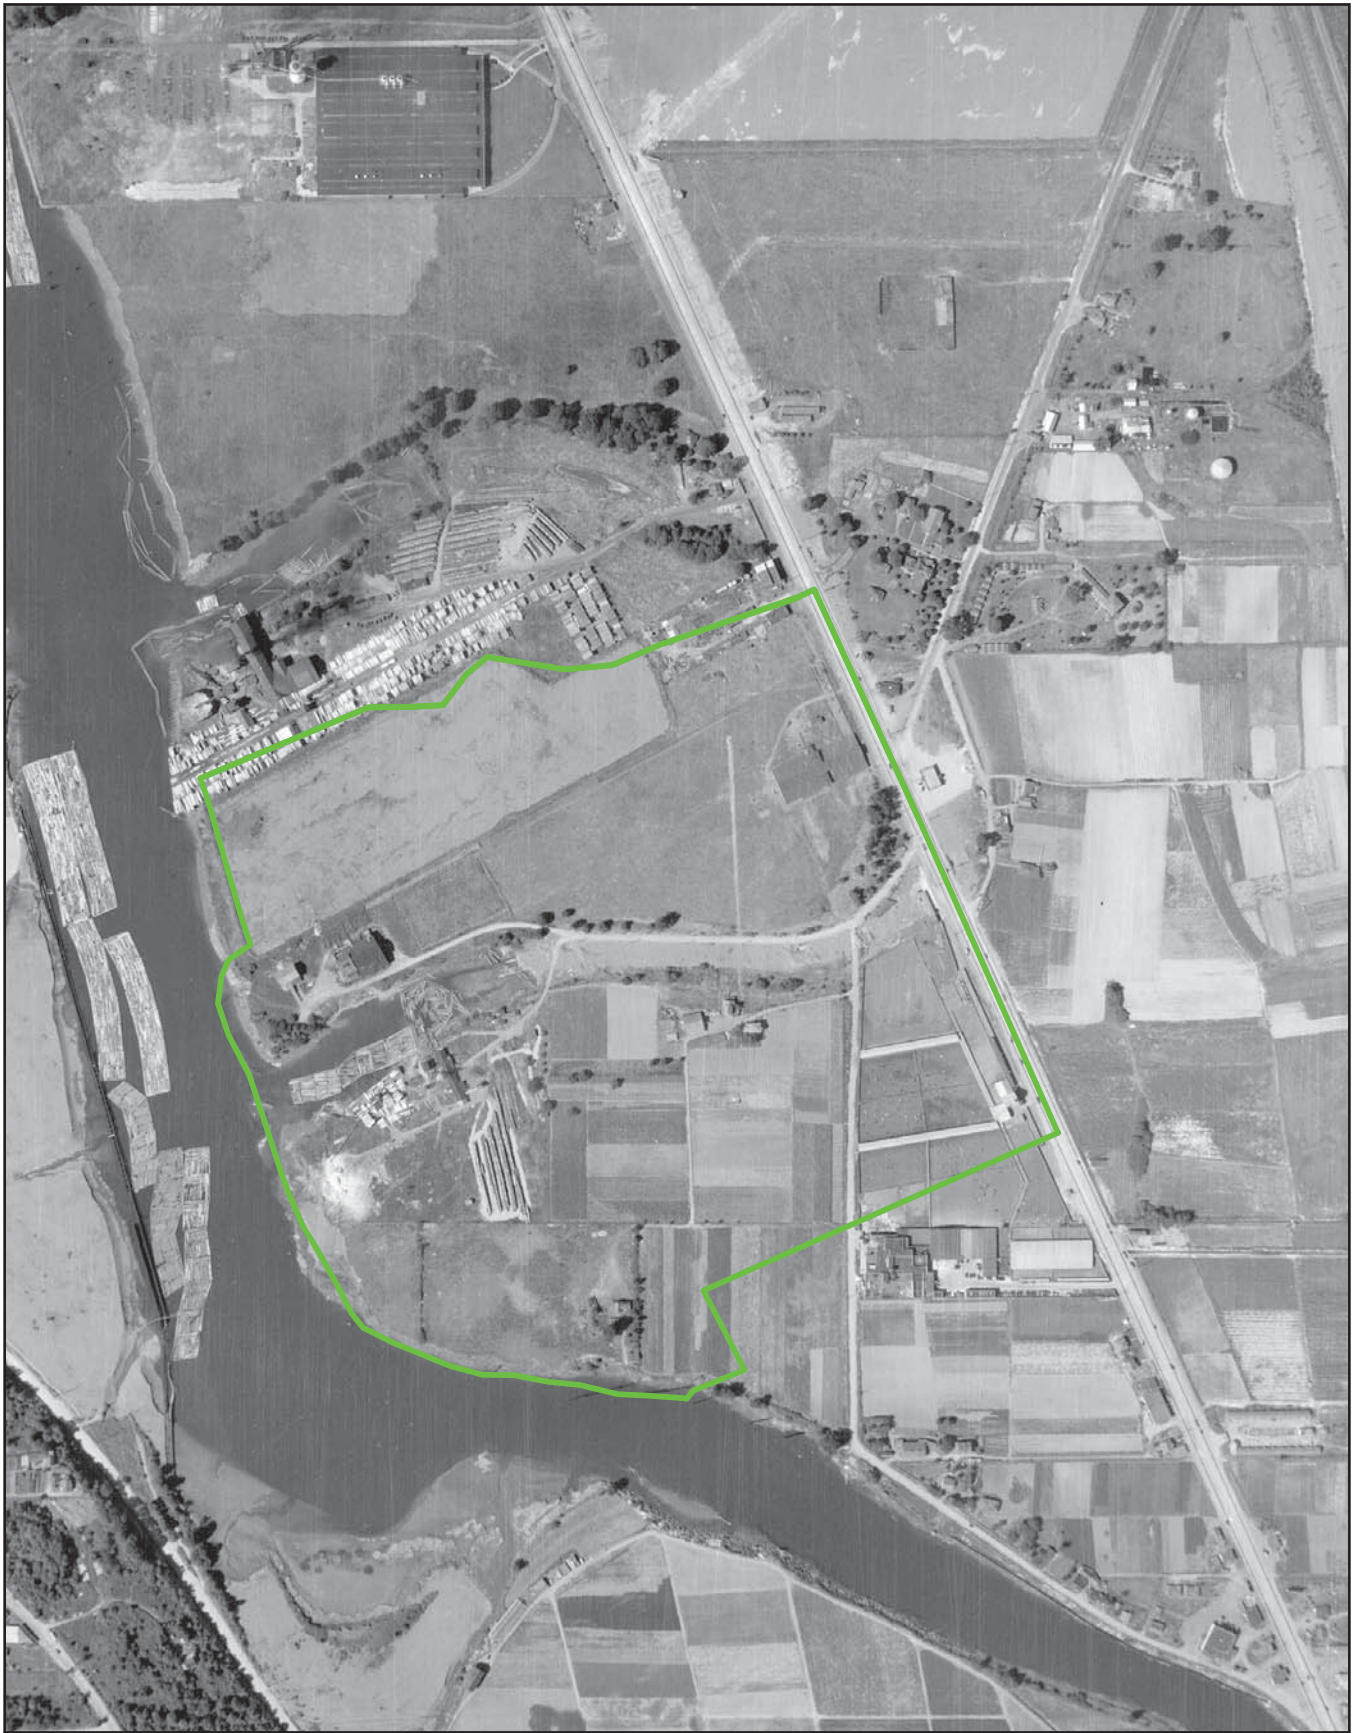
**Figure B-1. RM 4.3-4.9 East
(Boeing Developmental Center): 1936**

Slip 6 is already well defined and appears similar to the current size and shape although it is narrower at its entrance due to the presence of mudflats on the north side. There are logs floating in the slip adjacent to the lumber mill. No piers are in the slip at this time. The area immediately to the north of Slip 6 (Container Properties LLC) appears cleared but undeveloped.

The area south of Slip 6 was occupied by a lumber mill, as evidenced by the logs floating in the slip and what appear to be upwards of 100 stacks of milled lumber. One or two large buildings and possibly some smaller buildings comprised the lumber mill. The land immediately south of the lumber mill was cleared and vacant. To the northeast of the vacant land, adjacent to what is now Marginal Way and at the northern boundary of the Museum of Flight, were what appear to be four or five small structures and possibly a circular tank. Just south were two more buildings and some unidentified structures. These buildings were in the area approximately where Building 9-04 (the Museum of Flight) exists today and may have been the former location of Washington Compressed Gas or the American Winegrower's Association winery described in the RCRA assessment document (SAIC 1994). What appear to be four round tanks can be seen behind the buildings. Further to the south, a large building fronted Marginal Way where the current large parking lot north of S 96th Place is today. The purpose of this building is unknown.

To the south of S 96th Place were a collection of buildings and cleared land that may have been the stockyard and meat packing plant described in the RCRA assessment (SAIC 1994). Although no railroad tracks can be seen in the photo, there appears to be a line of railroad cars between the buildings and Marginal Way. The BDC RCRA assessment indicated that railroads once occupied part of the property, although the time period and location was not known. Further south of S 96th Place, at about where Building 9-110 and the eastern portion of Building 9-101 are today, was a large complex of buildings including at least one warehouse-sized structure. These buildings may have been associated with the stockyard and slaughterhouse as they appear to have been connected to the stockyard. A cluster of buildings, three residence-sized and one larger, fronted Marginal Way to the south in the area that is now the eastern portion of the south parking lots. One of those residences still exists at 10035 East Marginal Way South and is owned by East Marginal Associates; this residence is not a part of the BDC facility. This cluster of

buildings likely included the grocery store and gas station described in the RCRA assessment because the assessment mentions that the grocery/warehouse building burned down in the 1940s and the larger of the buildings appears razed and the ground blackened in the 1946 photograph.

South of the vacant area to the south of the lumber mill were two more buildings in the approximate location of the current Building 9-99, and another small slip with floating logs. South of the small former Slip 7 there was at least one large building and possibly two or three smaller buildings. This area also contained stacks of logs and/or milled lumber. East of Slip 7 the land appears to have been cultivated. Three buildings are clearly visible at the northern edge of the farmed land. Another building, potentially a residence, was located just off the LDW at the southern edge of the farmed land approximately in the area of the current Building 9-120. The in-water structures that can be seen south of Buildings 9-120 and 9-80 in current aerial photos are visible in the view from 1936.

With the exception of the structures mentioned above, and a possible small dock at the southern end of the northernmost lumber mill, there appears to be relatively little use of the LDW for moorage or waterway. A possible wall or riprap structure is visible along the LDW shoreline for almost the entire length of what is now S 104th Street. In 1936 there were multiple structures fronting the north side of that road with more cultivated land behind them to the north. Those buildings would have occupied the land where the southern parking lots now lie.

The area to the south, currently referred to as the Strick Lease Storage Yard, was primarily cultivated with two or three possibly residential buildings along the road that is known as S 104th Street.

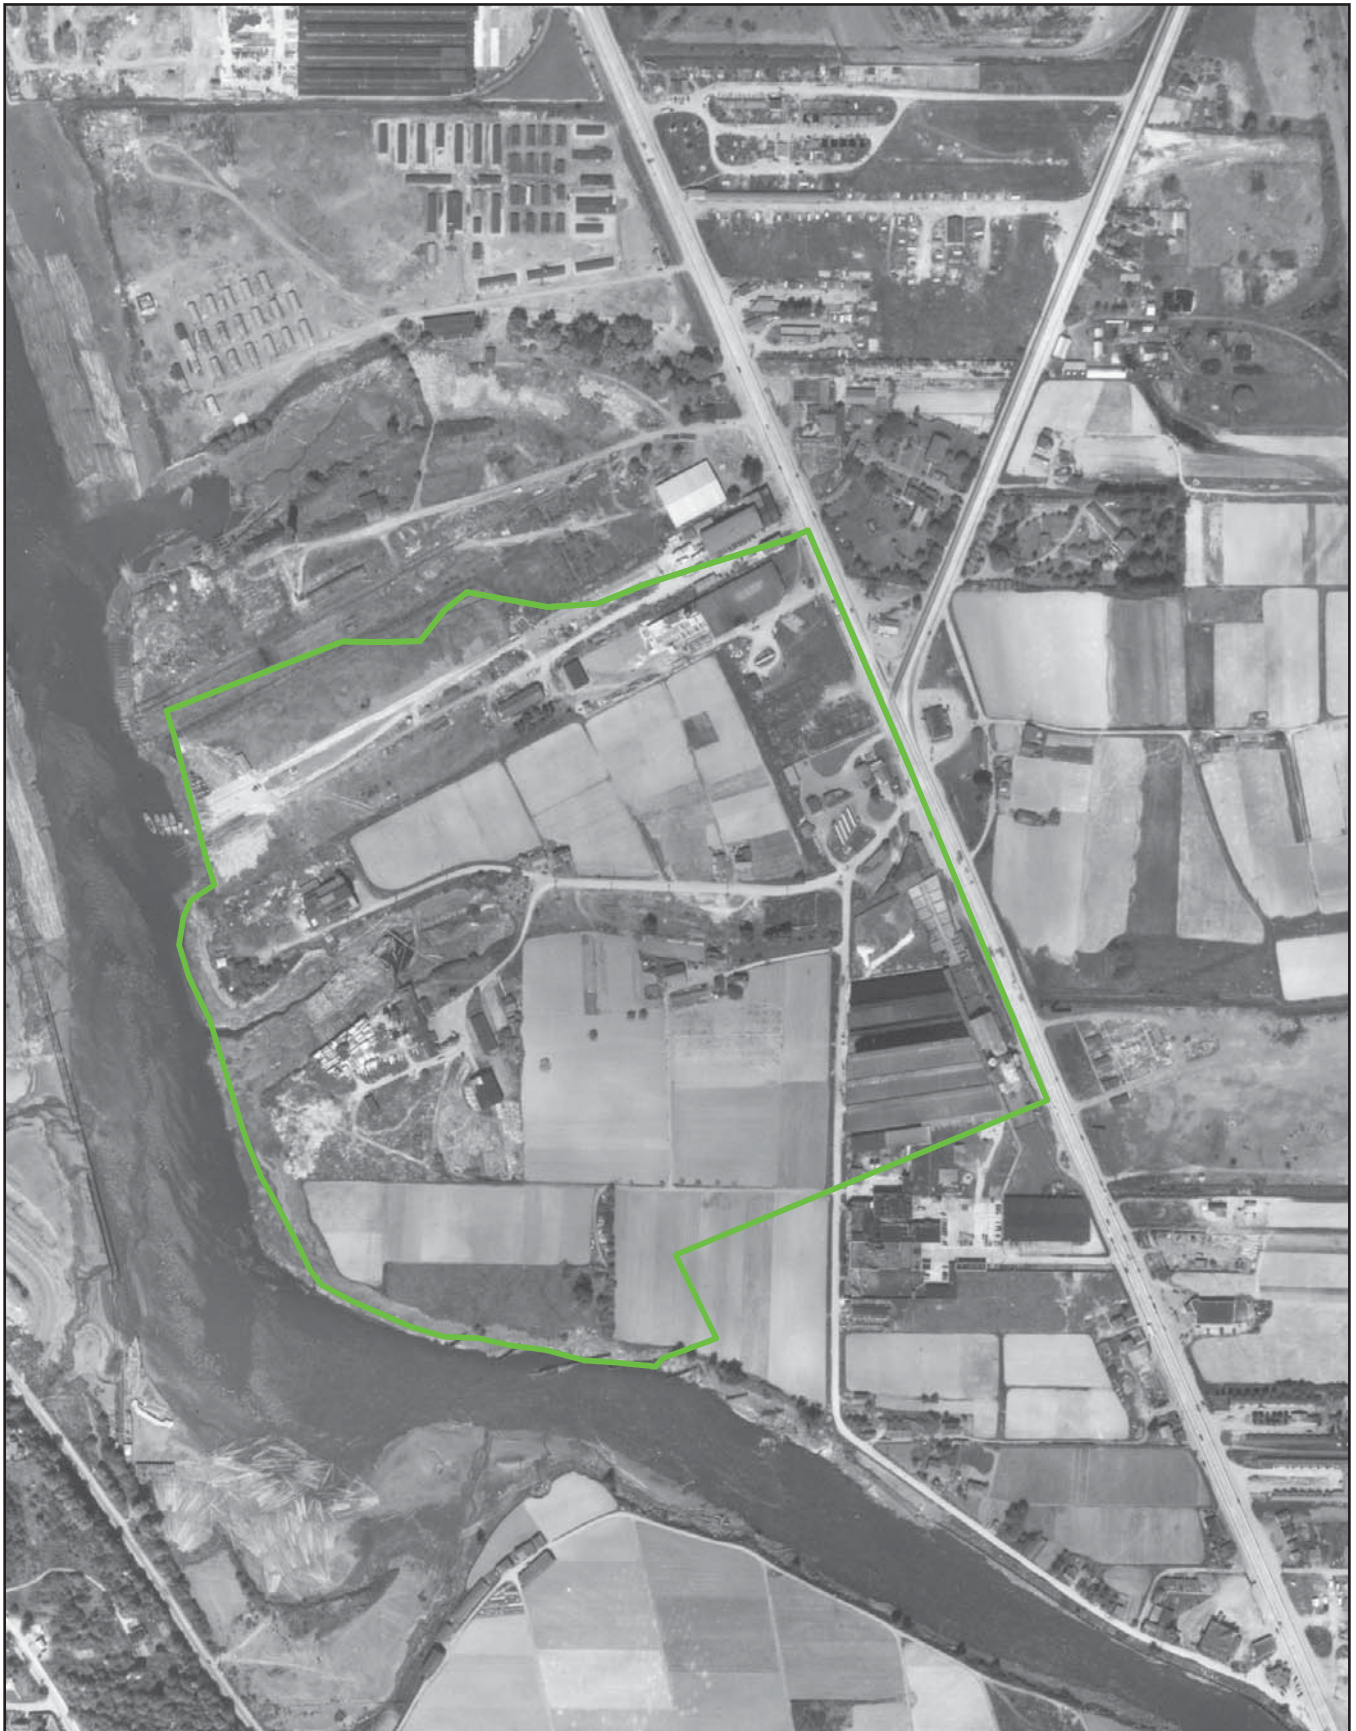
**Figure B-2. RM 4.3-4.9 East
(Boeing Developmental Center): 1946**

This photograph documents the increased development taking place along the LDW. The eastern half of Slip 6 appeared to have silted in. Several of the buildings from the lumber mill on the southwest side of Slip 6 had been razed and the piles of milled lumber were no longer present on that portion of the property. A large shadow indicates the presence of some kind of tower or stack at this location.

One of the buildings and the possible tank structure in the northeast corner are no longer visible in 1946. To the south, the four tanks seen in the 1936 photograph cannot be seen in the one taken in 1946. However, additional structures were constructed in that area and 12 tanks (4 large and 8 smaller) were constructed farther back from Marginal Way.

The two buildings to the south seen in the 1936 photograph were razed some time before 1946 and more structures were present just south of that area. Additional structures are also visible in the area where the stockyard and slaughterhouse appeared to be in 1936. A line of train cars were also present between the buildings and Marginal Way.

To the south of the stockyard the large grocery/warehouse building visible along Marginal Way in the 1936 photograph appears razed and the ground blackened in the 1946 photograph. The area that today is the south parking lots and Strick Lease Storage Yard appeared largely cultivated or vacant in 1946, with the exception of the portions of the property directly adjacent to the roads.

The smaller of the two buildings north of Slip 7 had been razed and the slip itself appeared to be largely filling in with the only water being in a creek with small branches. Three additional structures were built to the east of the lumber piles at this slip and a cluster of small structures

were built across the road to the northeast of the mill. To the north of Slip 7 a ladder or stair type structure had been built out into the LDW and four or five boats were moored along the shore.

The small structure (a residence?) visible southeast of the lumber yard on Slip 7 in the 1936 photograph appears to have been razed by the time the 1946 photograph was taken. The adjacent land to the west also appears to have been cultivated.

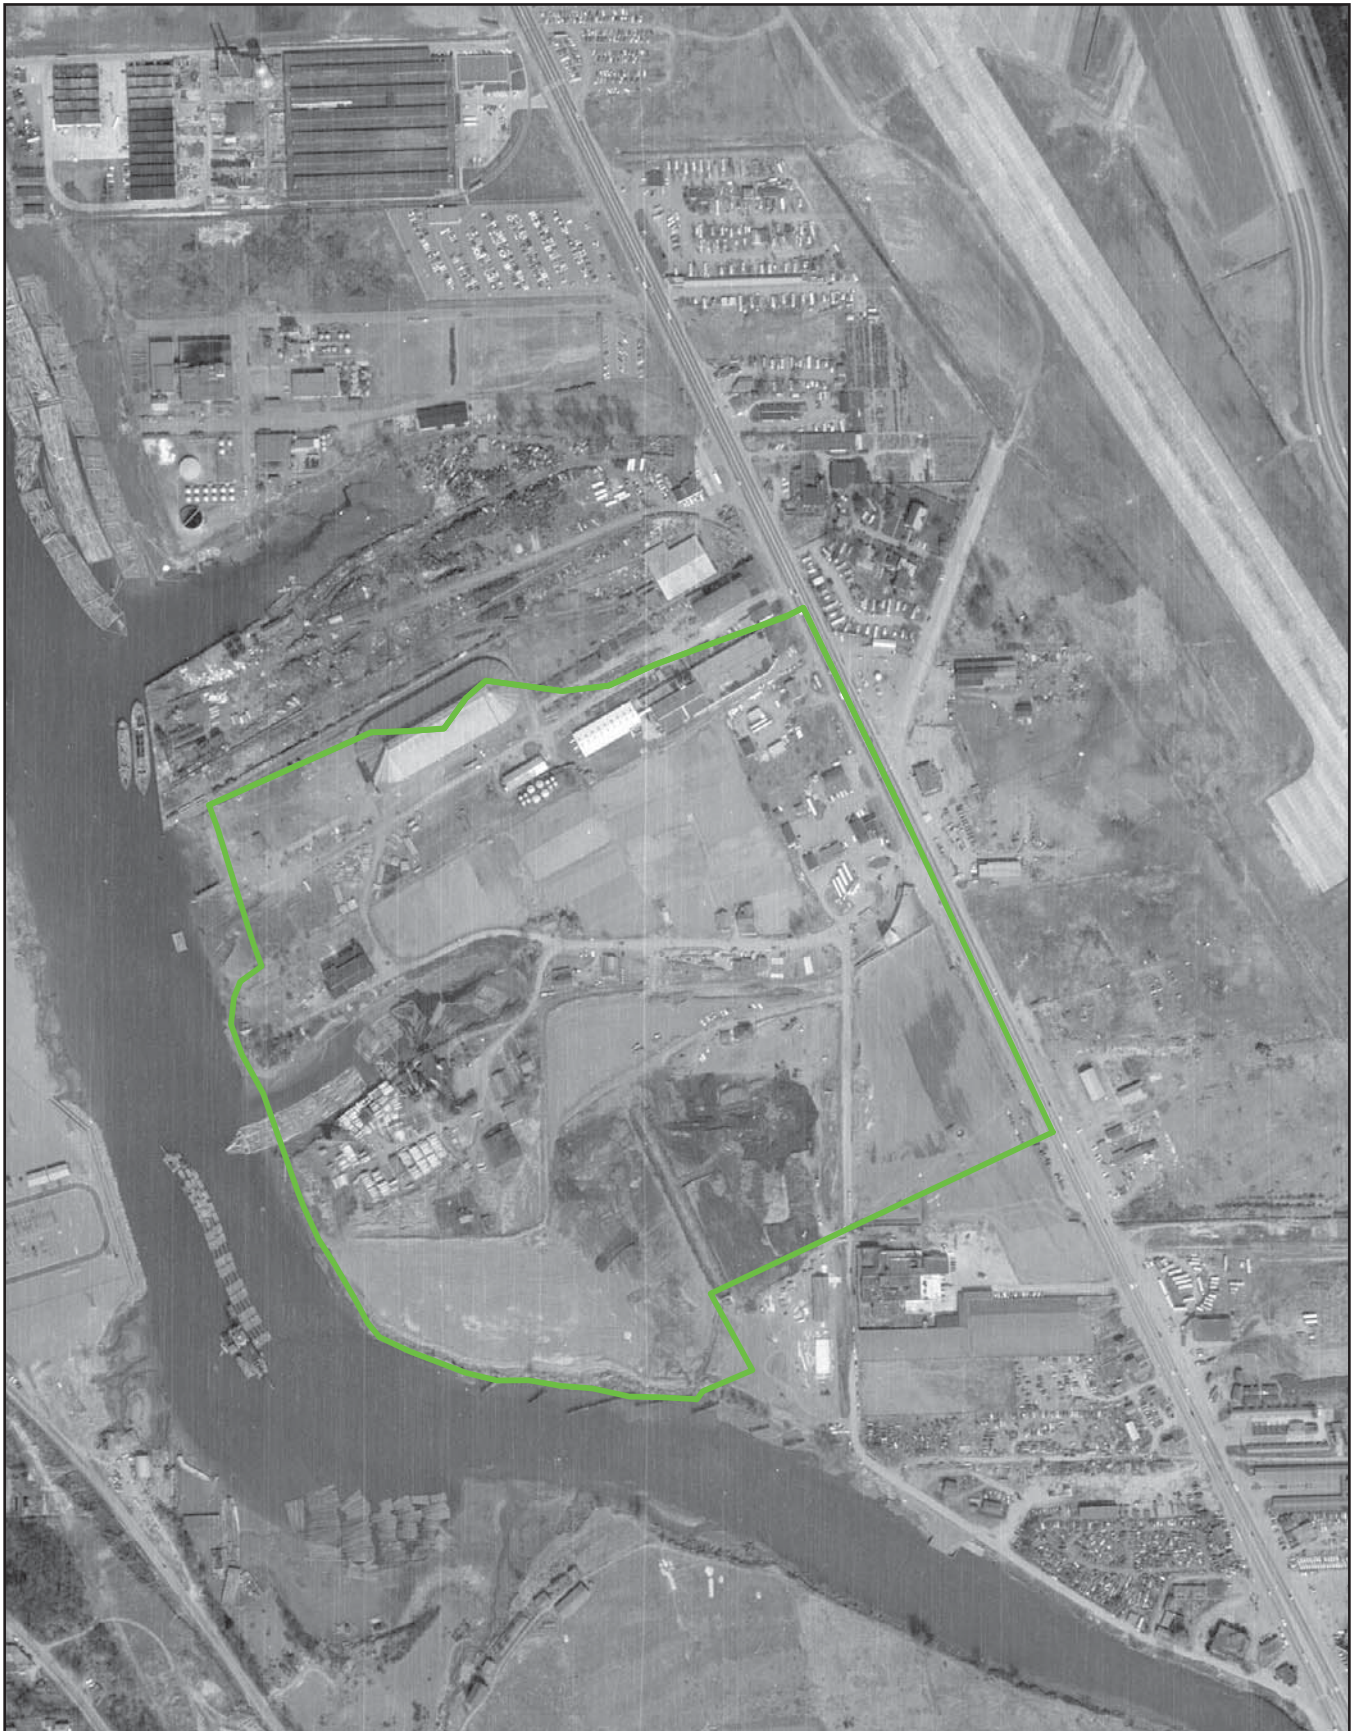
**Figure B-3. RM 4.3-4.9 East
(Boeing Developmental Center): 1956**

The interior portion of Slip 6 appears to have silted in, with water entering the slip from the north side. The land across Slip 6 at the current Container Properties location was developed with multiple buildings and 2 large and 12 smaller storage tanks. The area on the south side of Slip 6 that was occupied by the lumber yard appears to have been covered in debris. Only one of the buildings seen in the 1936 photograph was still present in 1956. There also appears to be multiple railroad tracks crossing this area with two lines of cars going right up to the LDW shoreline. Two ships were tied up along the LDW shoreline just south of Slip 6. The 77,000-square foot granary was built south of the lumber mill within the last decade and can be seen in this photograph.

East of the granary, an additional large building was constructed and the four large and eight smaller storage tanks were more clearly visible. Additional structures were constructed to the south, in approximately the area that is currently the south side of Building 9-51. More structures were also constructed along the south side of what is now S 96th Place.

The area that was likely the stockyard seen in the photographs from 1936 and 1946 was almost entirely cleared by 1956. No train cars appear in that area of the property in 1956. Clearing of land in the central southern portion of the property was begun for construction of what are now Buildings 9-101, 9-50, 9-65, 9-80, 9-120, 9-130, and 9-140.

The lumber yard at Slip 7 was still apparent in 1956, with multiple buildings, log booms, and stacks of milled lumber.

The auto wrecking yard is clearly visible in the area that is currently the south parking lots and the Strick Lease Storage Yard. There appears to be one large possible warehouse structure immediately north of the wrecking yard with an additional large building north of that. It is unclear if those buildings are associated with the wrecking yard or were a separate entity. Approximately nine structures appeared to be within the wrecking yard lot.

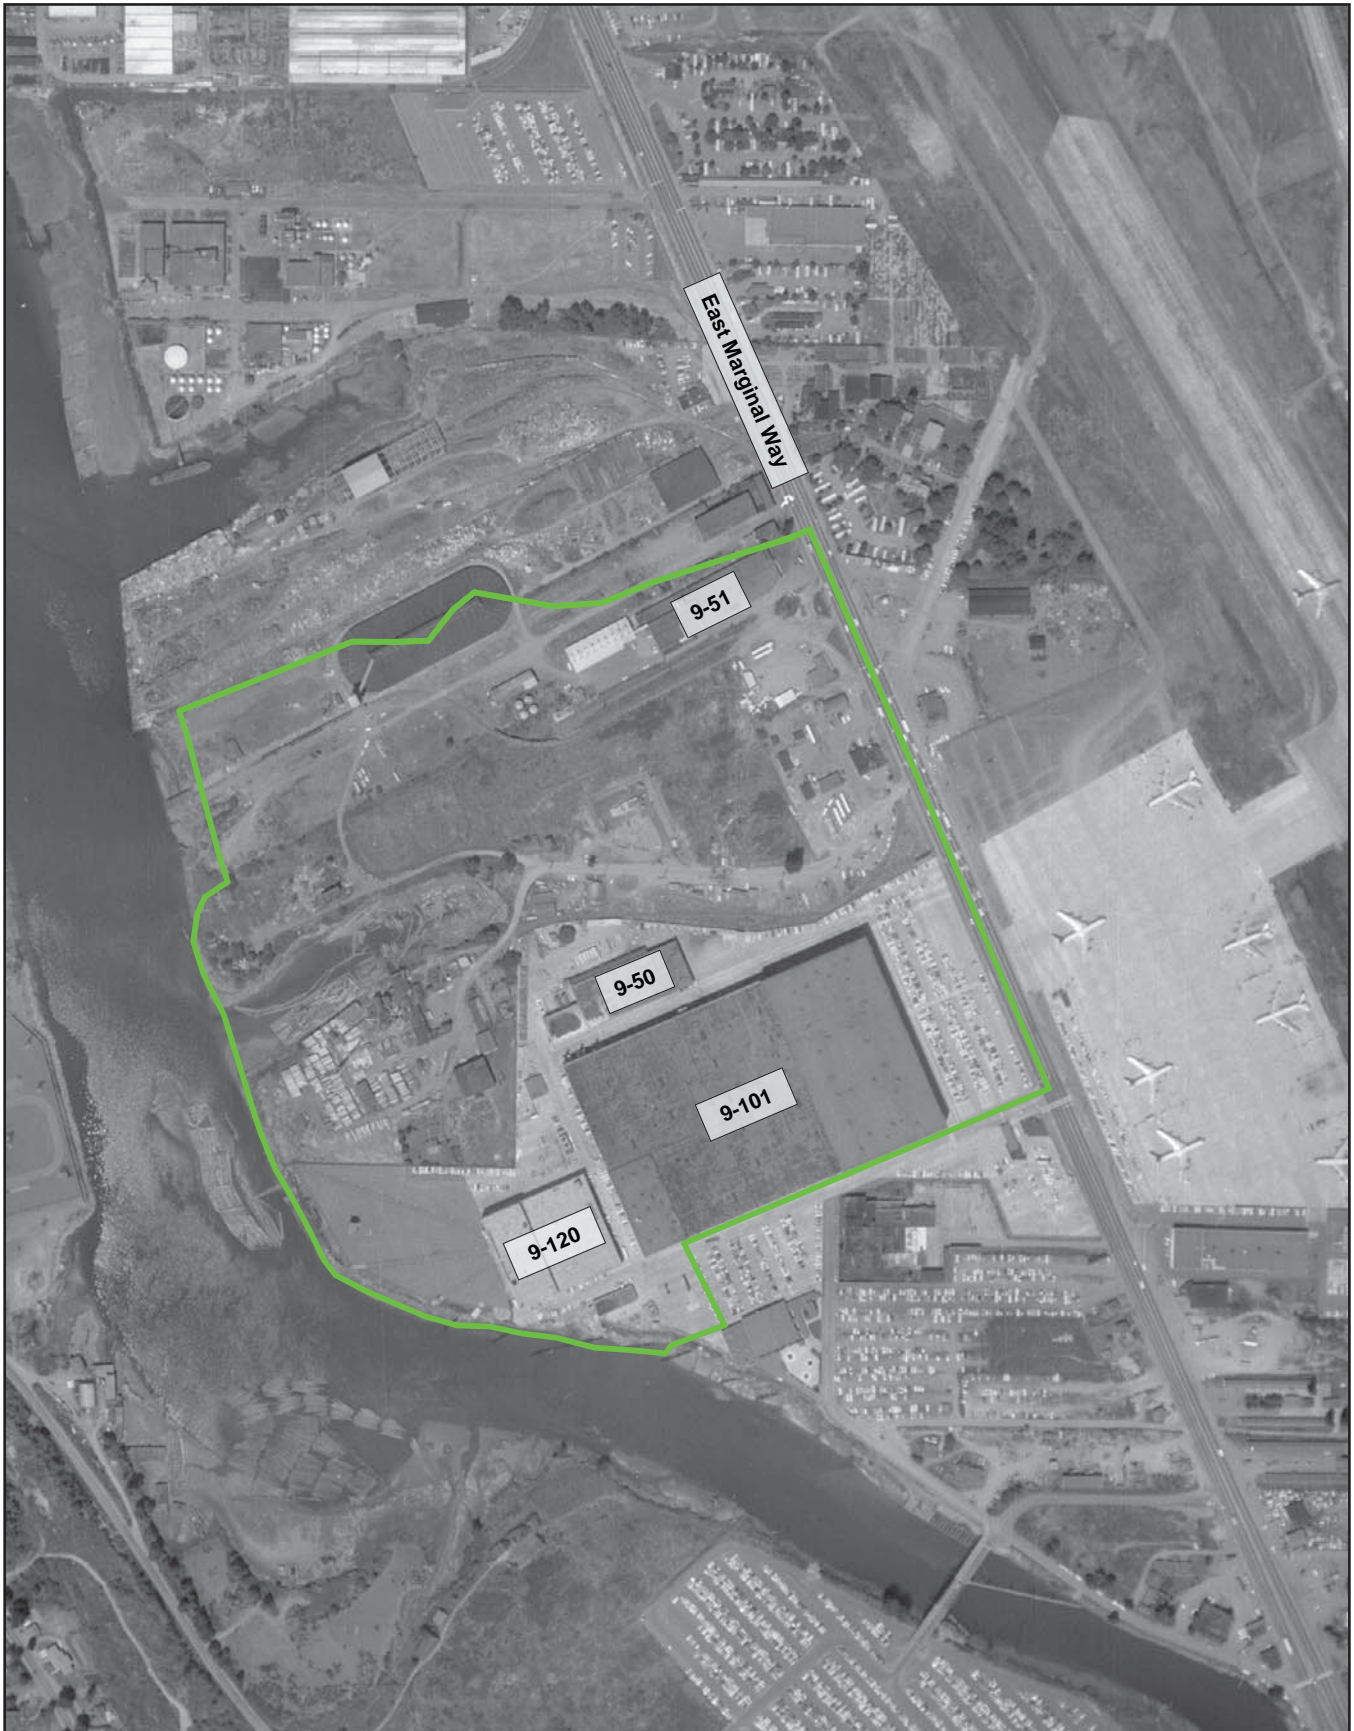
**Figure B-4. RM 4.3-4.9 East
(Boeing Developmental Center): 1960**

A large building appears to be either under construction or demolition on the south shore of Slip 6 at the former location of the lumber mill. The ground appears to be covered in debris in several places in this area. There were multiple lines of train cars in this area, with some stopped right by the LDW shoreline. No boats or barges, however, were tied up along the shore in this area. At least one of the train lines serviced the granary. Southeast of the granary, the eight smaller storage tanks were removed, with the four larger tanks remaining.

Slip 7 in the central portion of the property was still being used to float lumber in 1960. Slip 7 was in the area now occupied by the northern portion of Building 9-96 and the western portion of Building 9-98. The building on the north side of Slip 7 was either partially or totally demolished; in the photograph taken in 1960 a small building or portion of the larger building was still

standing. At least one dozen structures associated with the lumber mill as well as dozens of stacks of milled lumber can be seen on the land south of the slip.

The two buildings seen in the 1956 photograph in the approximate location of the current Building 9-55 were demolished and the land cleared in the 1960 photograph.

The following buildings were constructed on the southern half of the property by Boeing: 9-101 (smaller in 1960 than it is today), 9-50, 9-65, 9-80, 9-120, 9-130, and 9-140. There is also a structure in the 1960 aerial photograph in the approximate location of what is now Building 9-94 or the adjacent parking lot; however, that structure does not appear to have the size and shape, and it may have been completely or partially torn down prior to construction of Building 9-94 in 1961. Most of the southern half of the property was converted to impermeable surfaces during the period between the photographs taken in 1956 and 1960. A large circular storage tank was present at the north edge of the paved Boeing property, south of S 96th Place.

The large building complex that was just southwest of the stockyard in the earlier photographs was still present in 1960, surrounded by Boeing operations and buildings to the north and west. The two warehouse-sized buildings on the north side of the auto wrecking yard were replaced by what appears to be a dirt parking lot with some grassy or cleared space in the middle. It is unclear if the parking area was part of Boeing at that time. The wrecked cars as well as two of the 6 structures fronting Marginal Way had been removed. The bridge across the LDW at S 102nd Street was constructed.

The northern half of the Strick Lease Storage Yard to the south of the BDC was still vacant at the time the photograph was taken in 1960. A large swath of land to the east across Marginal Way was paved to create the Military Flight Center.

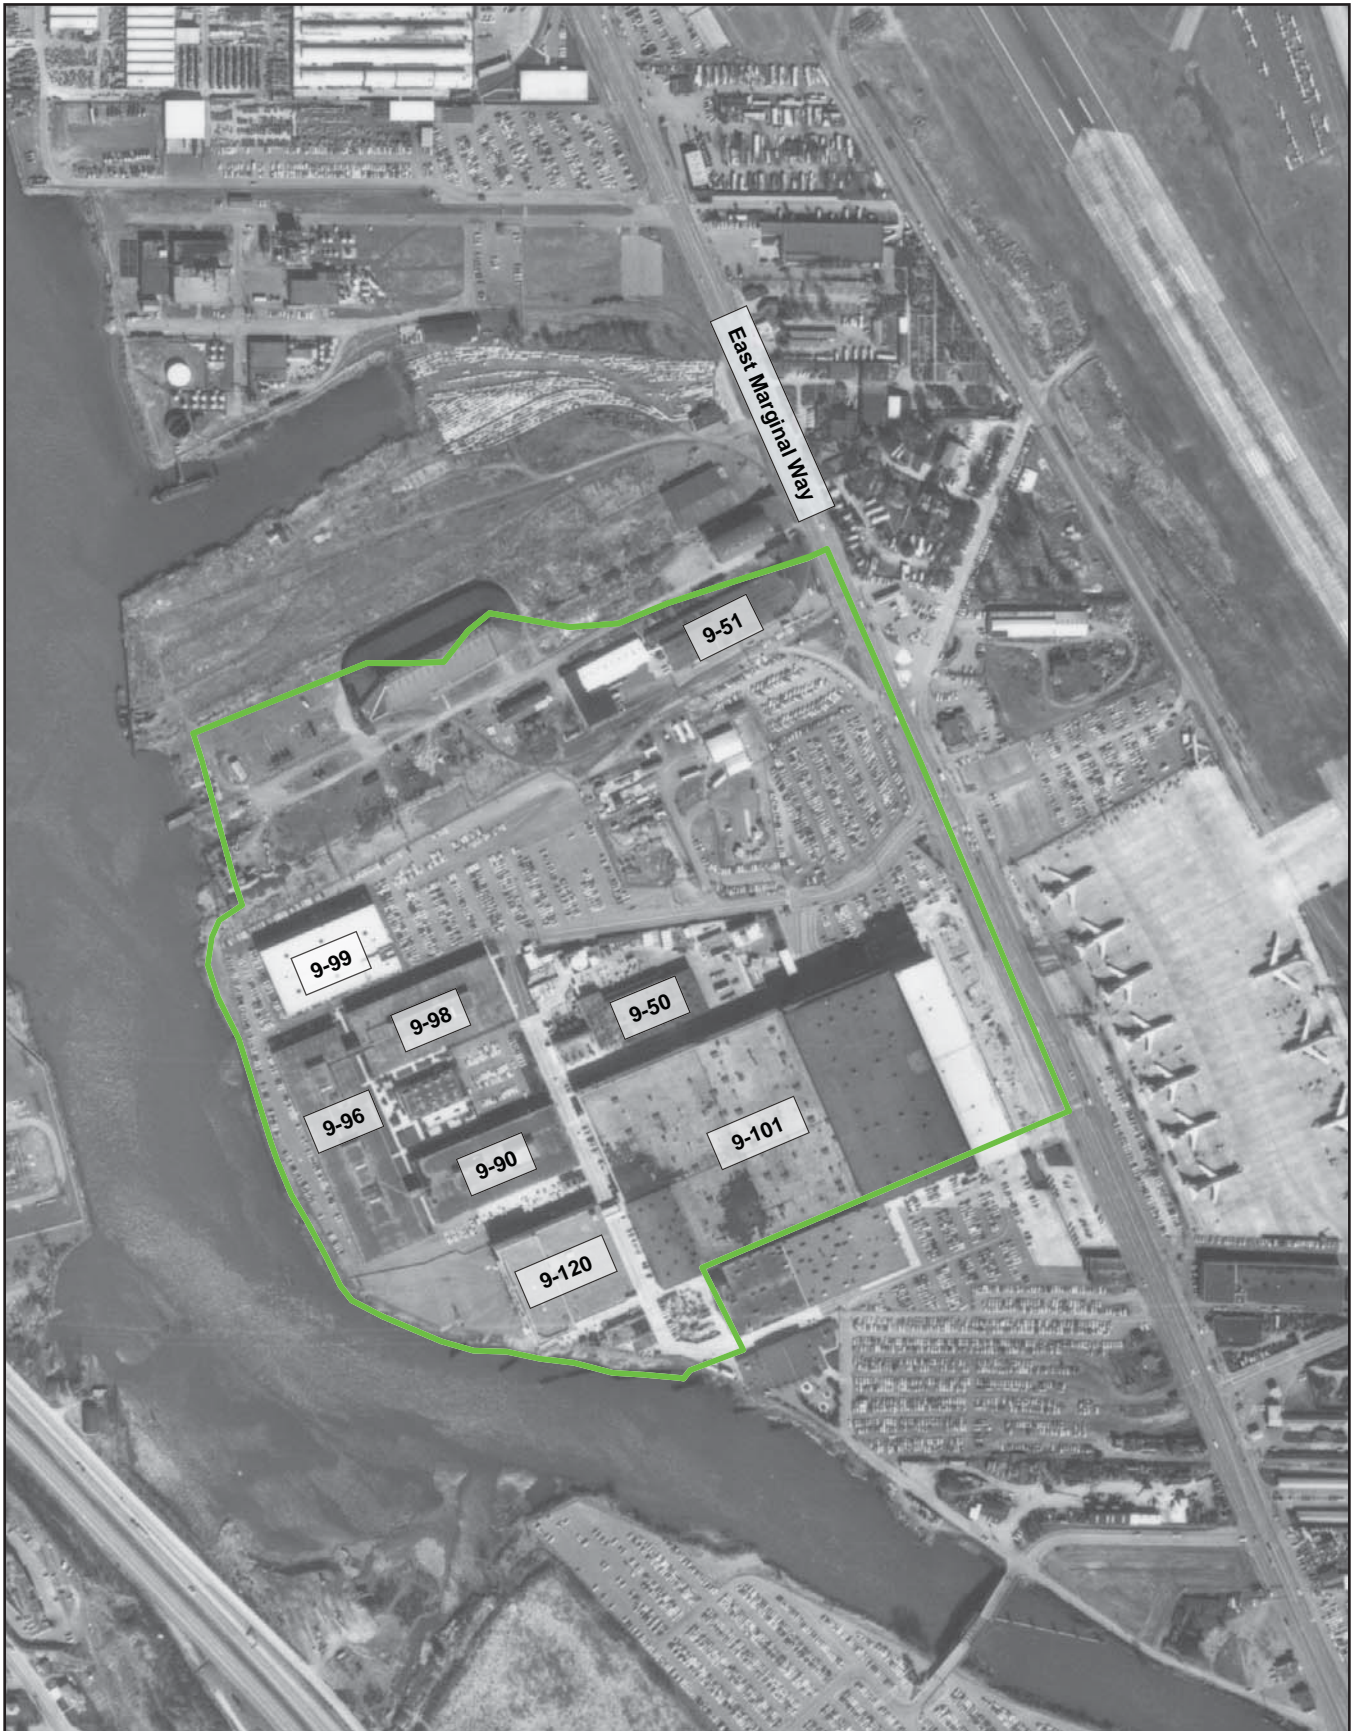
Figure B-5. RM 4.3-4.9 East
(Boeing Developmental Center): 1969

In 1969, Slip 6 was dredged and was in the shape and size it is today although the shoreline still appeared soft. Traces of the old lumber mill, including what appeared to be debris piles in the photographs from 1956 and 1960, were no longer apparent in 1969. Land at the head of the slip was a storage yard for what appear to be either train cars or trucks. No train cars are visible in the area of the former lumber mill or by the granary. A structure was built out into the LDW at the end of one of the rail lines southwest of the granary. The relatively tall shadow cast by the structure indicates it may have been a covered loading dock.

The cluster of approximately 10 buildings that were north of S 96th Place were demolished and replaced with a parking lot.

Buildings constructed during the previous period included: 9-35, 9-43, 9-48, 9-49, 9-59, 9-60, 9-61, 9-85, 9-90, 9-94, 9-96, and 9-98. Building 9-101 was expanded onto the parking lots to the east and south. Slip 7 was completely filled in and Building 9-99 and a large parking area were constructed in its place.

The building complex south of Building 9-101 that was formerly adjacent to the stockyard was demolished and replaced with part of the new building and a parking lot. Three structures were constructed on the very southern portion of the property north of S 102nd Street and it appeared to be used for storage of some kind. The Strick Lease Storage Yard property was cleared at the time the 1969 photograph was taken.

The sunken structure visible along the shoreline just downstream of the S 102nd Street bridge in current photographs can be seen in the photograph taken in 1969. It is possible this may have been a barge tied up along the shore or a ramp.

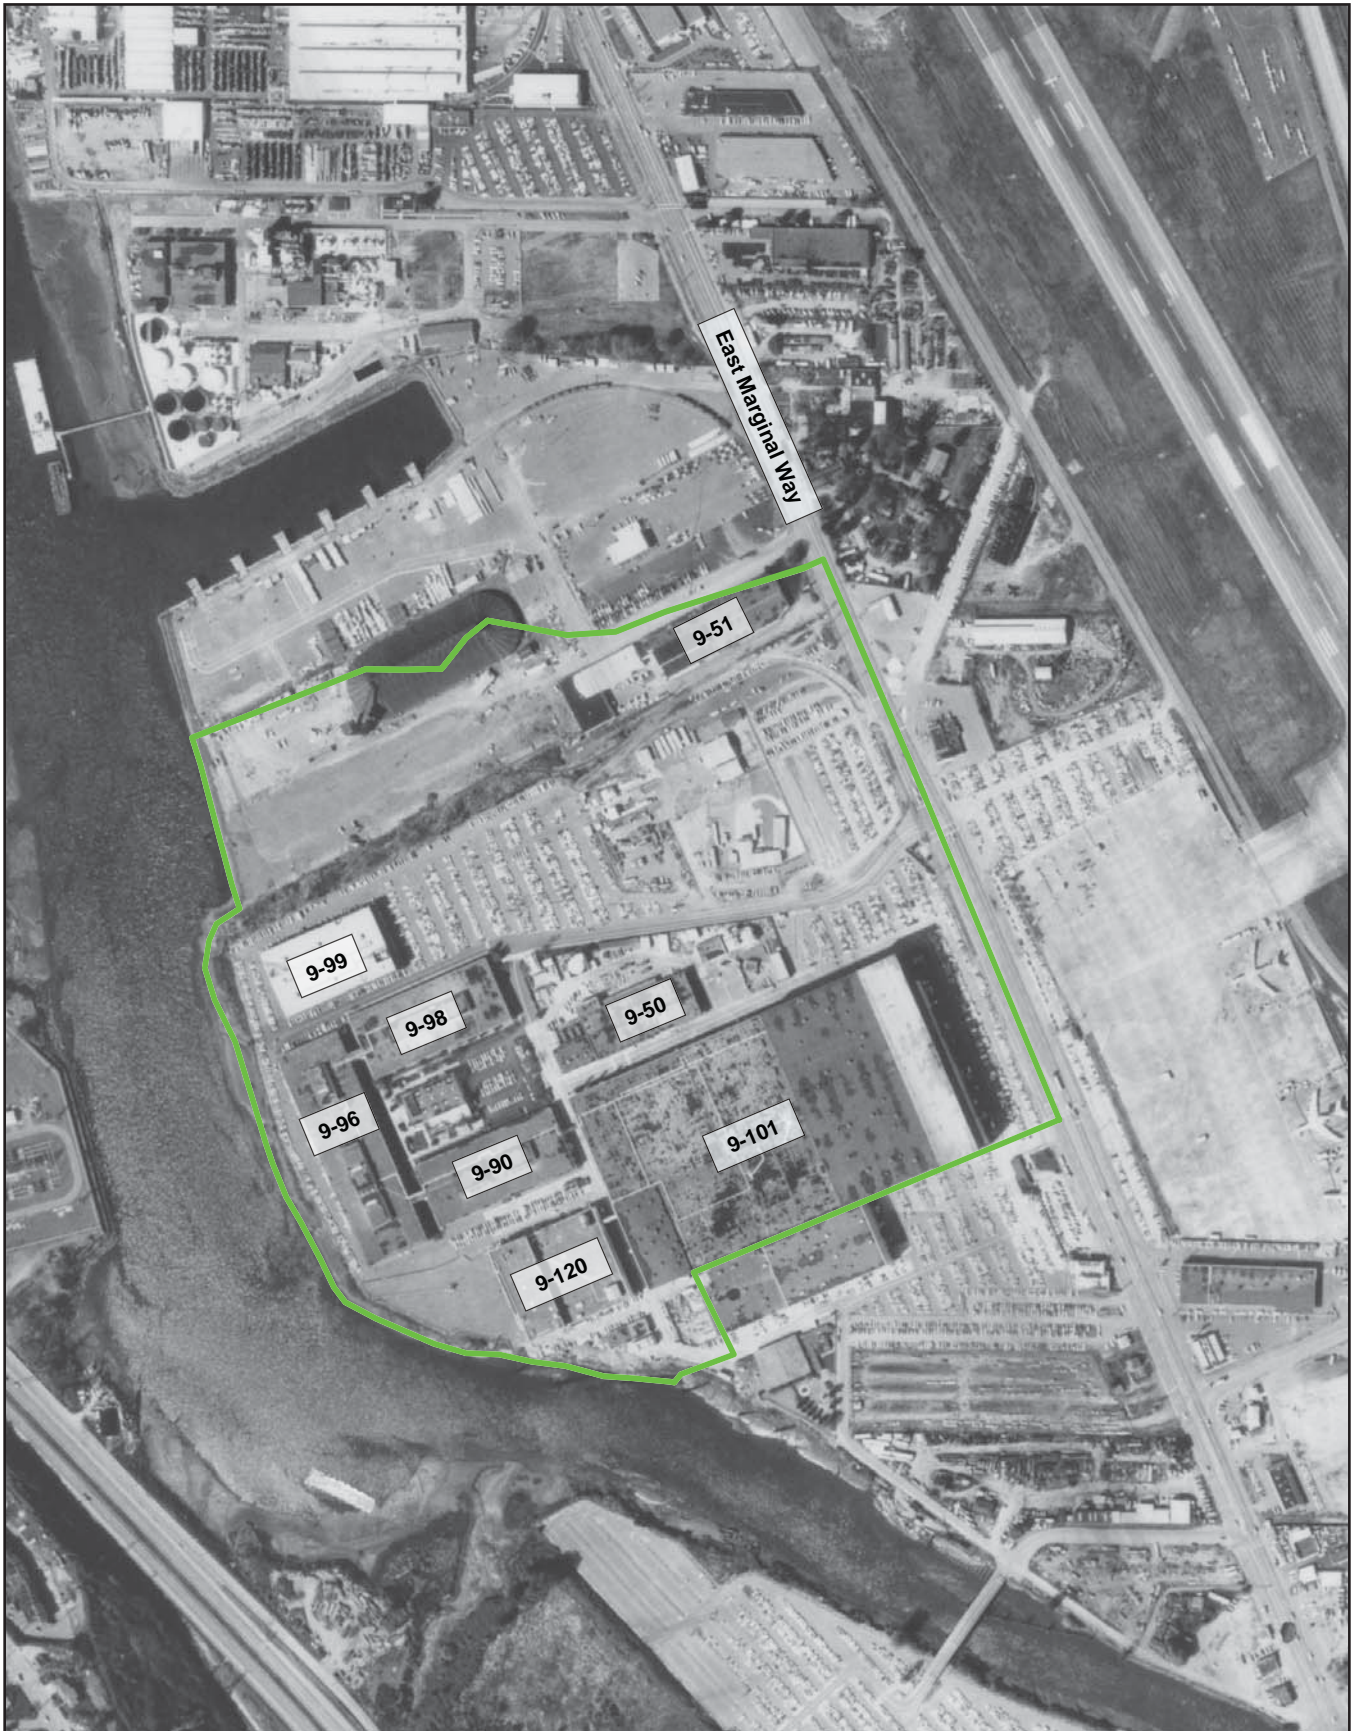
Figure B-6. RM 4.3-4.9 East
(Boeing Developmental Center): 1977

The six dock structures on the southern shoreline of Slip 6 were constructed and the shoreline appears hardened in the photograph taken in 1977. The area to the north of the granary appears to have been entirely paved and used for material transfers at the docks. The overwater structure that had been southwest of the granary was demolished or removed and the shoreline straightened and hardened or rip rapped from Slip 6 south to the Seattle City Light right-of-way.

The building that had been immediately south of the granary, and which may have been associated with the winery, had been demolished along with the four round storage tanks. Two new structures are visible immediately adjacent to the granary building on the southeast side.

A line of rail cars is clearly visible at the northeastern part of the property and the three buildings that had been in that area in 1969 were razed. The Port of Seattle bought this property in 1976 (SAIC 1994) and leased the land to Kenworth Truck Company and Transport Pool International for parking and storage.

Apart from the occasional tree, the strip of land that is currently the Seattle City Light right-of-way is the only area on the property in 1977 that appears to have had any vegetation. The right-of-way was clearly defined in this photograph although the overhead power lines were not yet visible.

Buildings 9-64 and 9-66 were constructed in 1970 and 1975, respectively.

More materials appear to be stored in the southernmost portion of the property that later became part of the south parking lots.

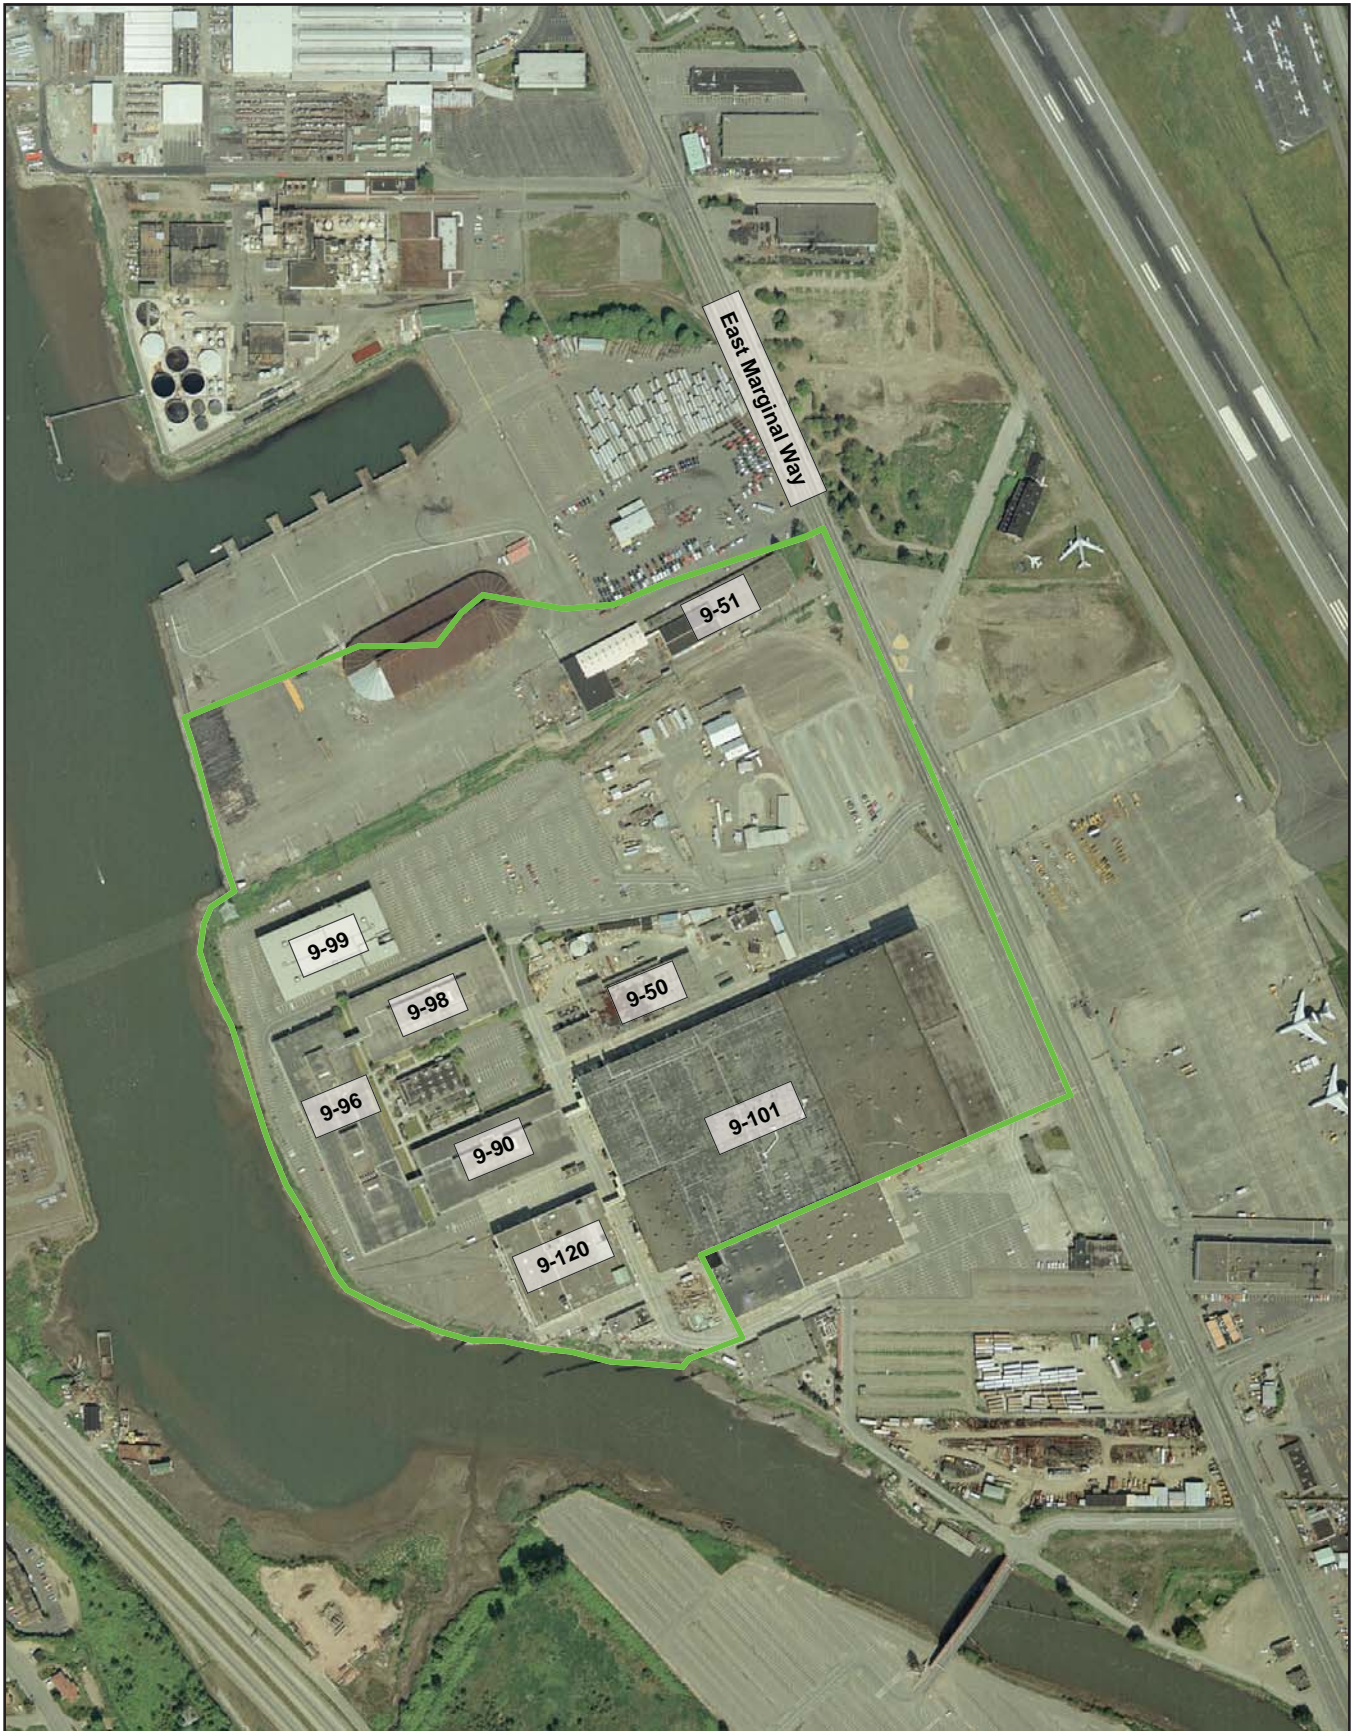
Figure B-7. RM 4.3-4.9 East
(Boeing Developmental Center): 1980

A small watercraft can be seen moored in Slip 6. The northeast portion of the property is clearly entirely paved in the photograph. Truck trailers can be seen stored in this area. No rail cars are evident, and it is unknown if the railroad tracks were still in existence in this area. To the south, the operations of Dallas-Mavis, a commercial trucking company (SAIC 1994), can be seen where upwards of one hundred big-rigs are parked.

Most of the structures and materials surrounding the granary building, including its loading/unloading structure, had been removed. A large debris pile can be seen adjacent to the LDW southwest of the granary. To the south, the power lines can be seen crossing the LDW from the Seattle City Light right-of-way.

Building 9-69/70 was constructed in 1980. However, a recent map of the BDC (Boeing 2009c) does not label this building and it is unclear from earlier maps (e.g., Figure 16 in EAA-7 Data Gaps Report by E&E 2007) if it is visible in the photograph taken in 1980. Building 9-54 was also constructed in 1980 but it does not appear to have been completed before the aerial photo was taken.

Rusty metal colored materials appear to be stored in the southernmost portion of the property that later became part of the south parking lots. What appear to be very large tires (tractor or trailer-sized?) can also be seen in this area in the 1980 photograph.

What might be a barge can be seen along the shoreline just north of the S 102nd Street bridge at the ramp-like structure. There appears to be one or two cranes onshore northwest of the structure in the water.
