**Lower Duwamish Waterway
RM 4.3-4.9 East (Boeing Developmental Center)**

Historical Aerial Photograph Review

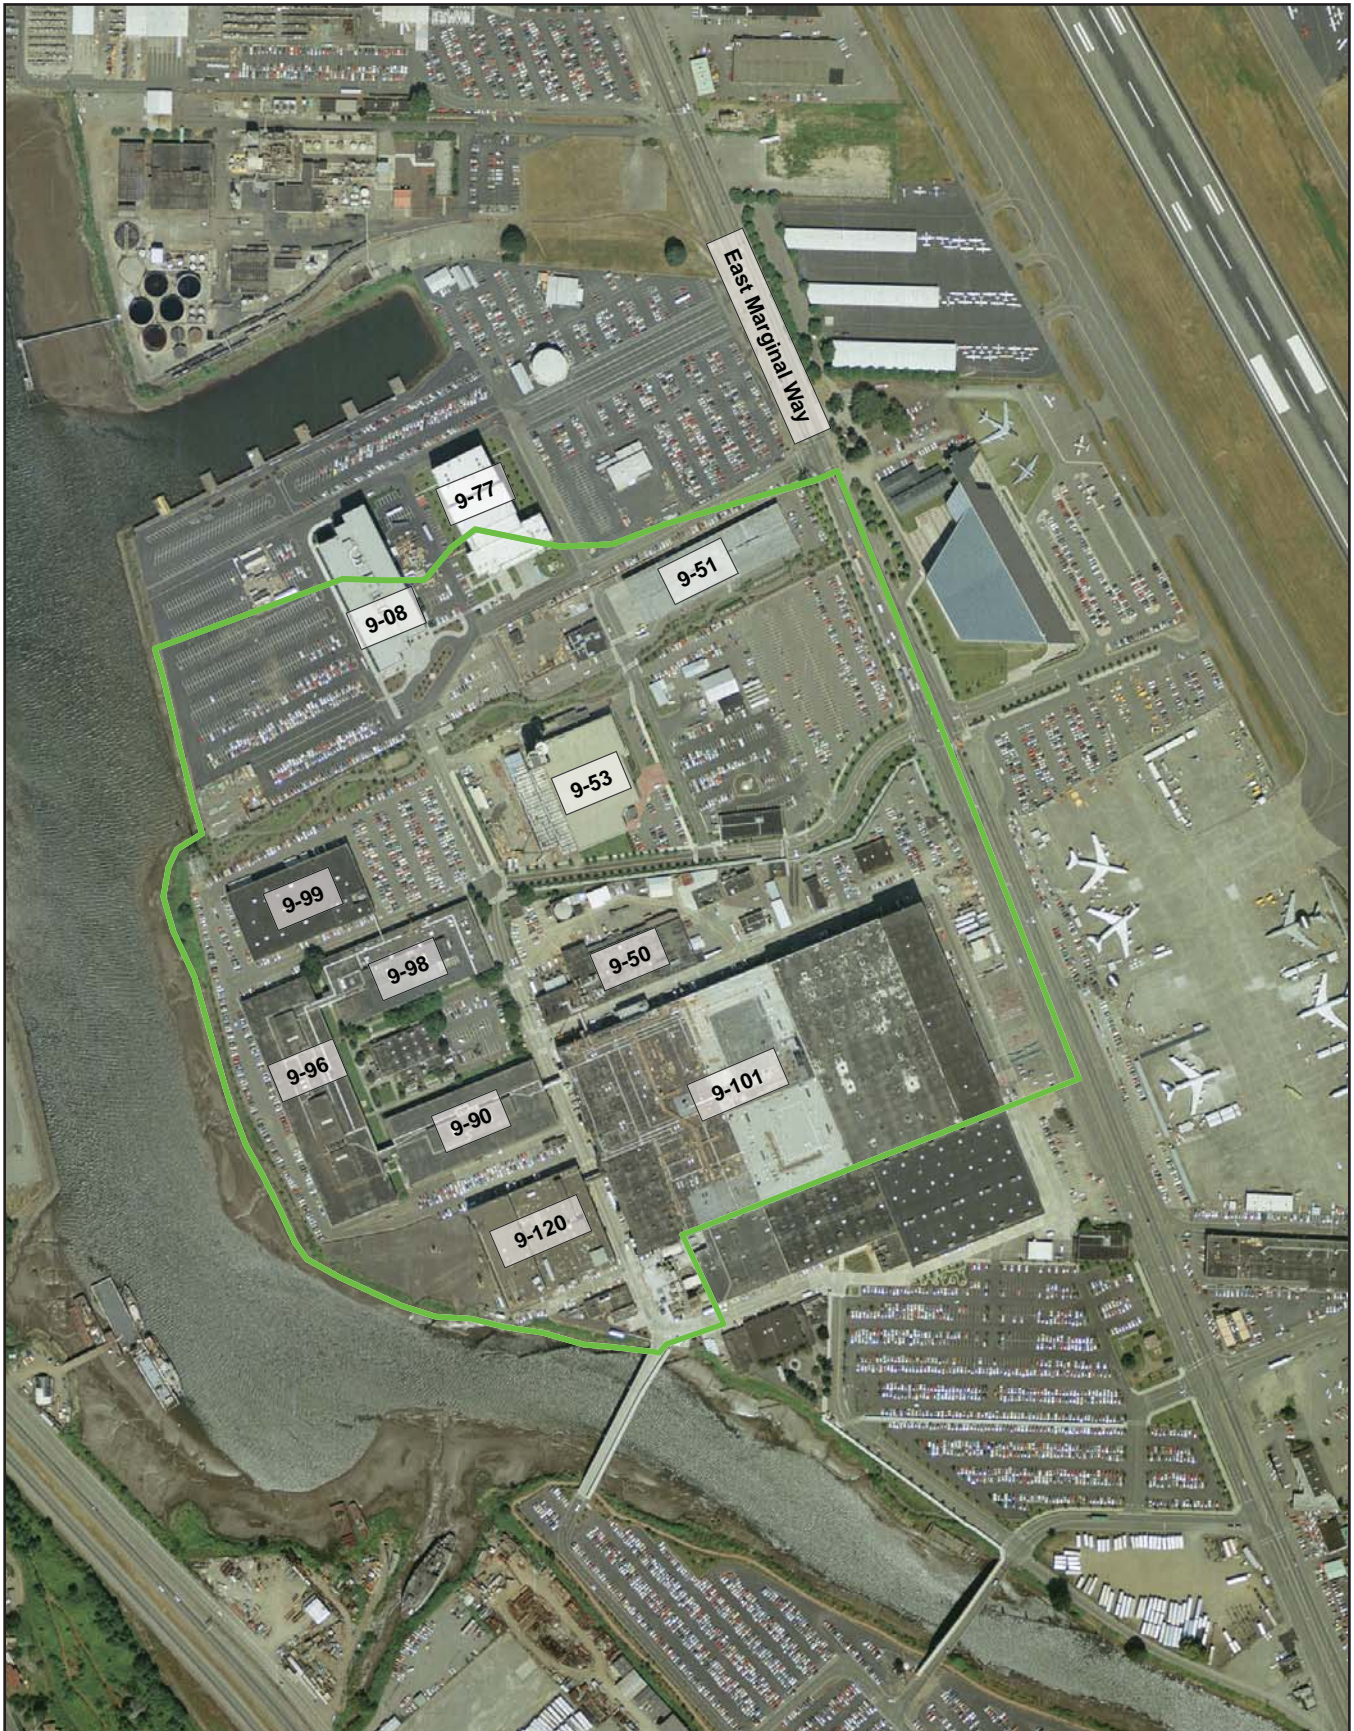
Figure B-8. RM 4.3-4.9 East
(Boeing Developmental Center): 1990

Several buildings were constructed at the BDC during the 1980s and the property began to look largely the way it does today. Buildings 9-05 and 9-07 can be seen in the northern part of the property as well as a large circular tank and Building 9-403, which is now part of the Museum of Flight. The Dallas-Mavis building can be seen but it does not appear as though that company was still operating on the property as the commercial trucks are gone and there were only a few trailers. The rest of that area was converted to parking.

The granary was demolished and Buildings 9-08 and 9-77 built in its location in 1990 and 1986, respectively. Large parking lots and small amounts of landscaping surrounded those buildings. To the south, a walking path and landscaping can be seen in the Seattle City Light right-of-way. To the east, the buildings that may have comprised the winery were demolished and replaced with Building 9-51, which was constructed in 1986. Building 9-52 was constructed west of 9-51 in that same year. A large parking lot was constructed southeast of Building 9-51. In 1987, the large Building 9-53 was constructed to the south of Building 9-52, between the right-of-way and S 96th Place.

Buildings 9-42 and 9-67 were constructed east of Building 9-50 in 1985. Building 9-103, directly adjacent to the north wall of 9-101, was also constructed in 1985. Four new structures that no longer exist can be seen in the photograph to the north and east of the northeast corner of Building 9-101. Building 9-102 was constructed to the southwest corner of Building 9-101 in 1983. A bridge was constructed over the LDW at the intersection of Francis Street and S 98th Street. What appears to be multiple above ground storage tanks (ASTs) can be seen on the perimeter of Building 9-101 on the southeast and southwest sides. Another structure that may have been a large AST can be seen just west of the bridge at S 98th Street by Building 9-85.

The south parking lots appeared in the 1990 photograph as they do today; all storage operations of truck trailers and unknown materials ceased. The crane(s) that had been along the shore northwest of the S 102nd Street bridge in the 1980 photograph was removed by the time the 1990 photograph was taken.

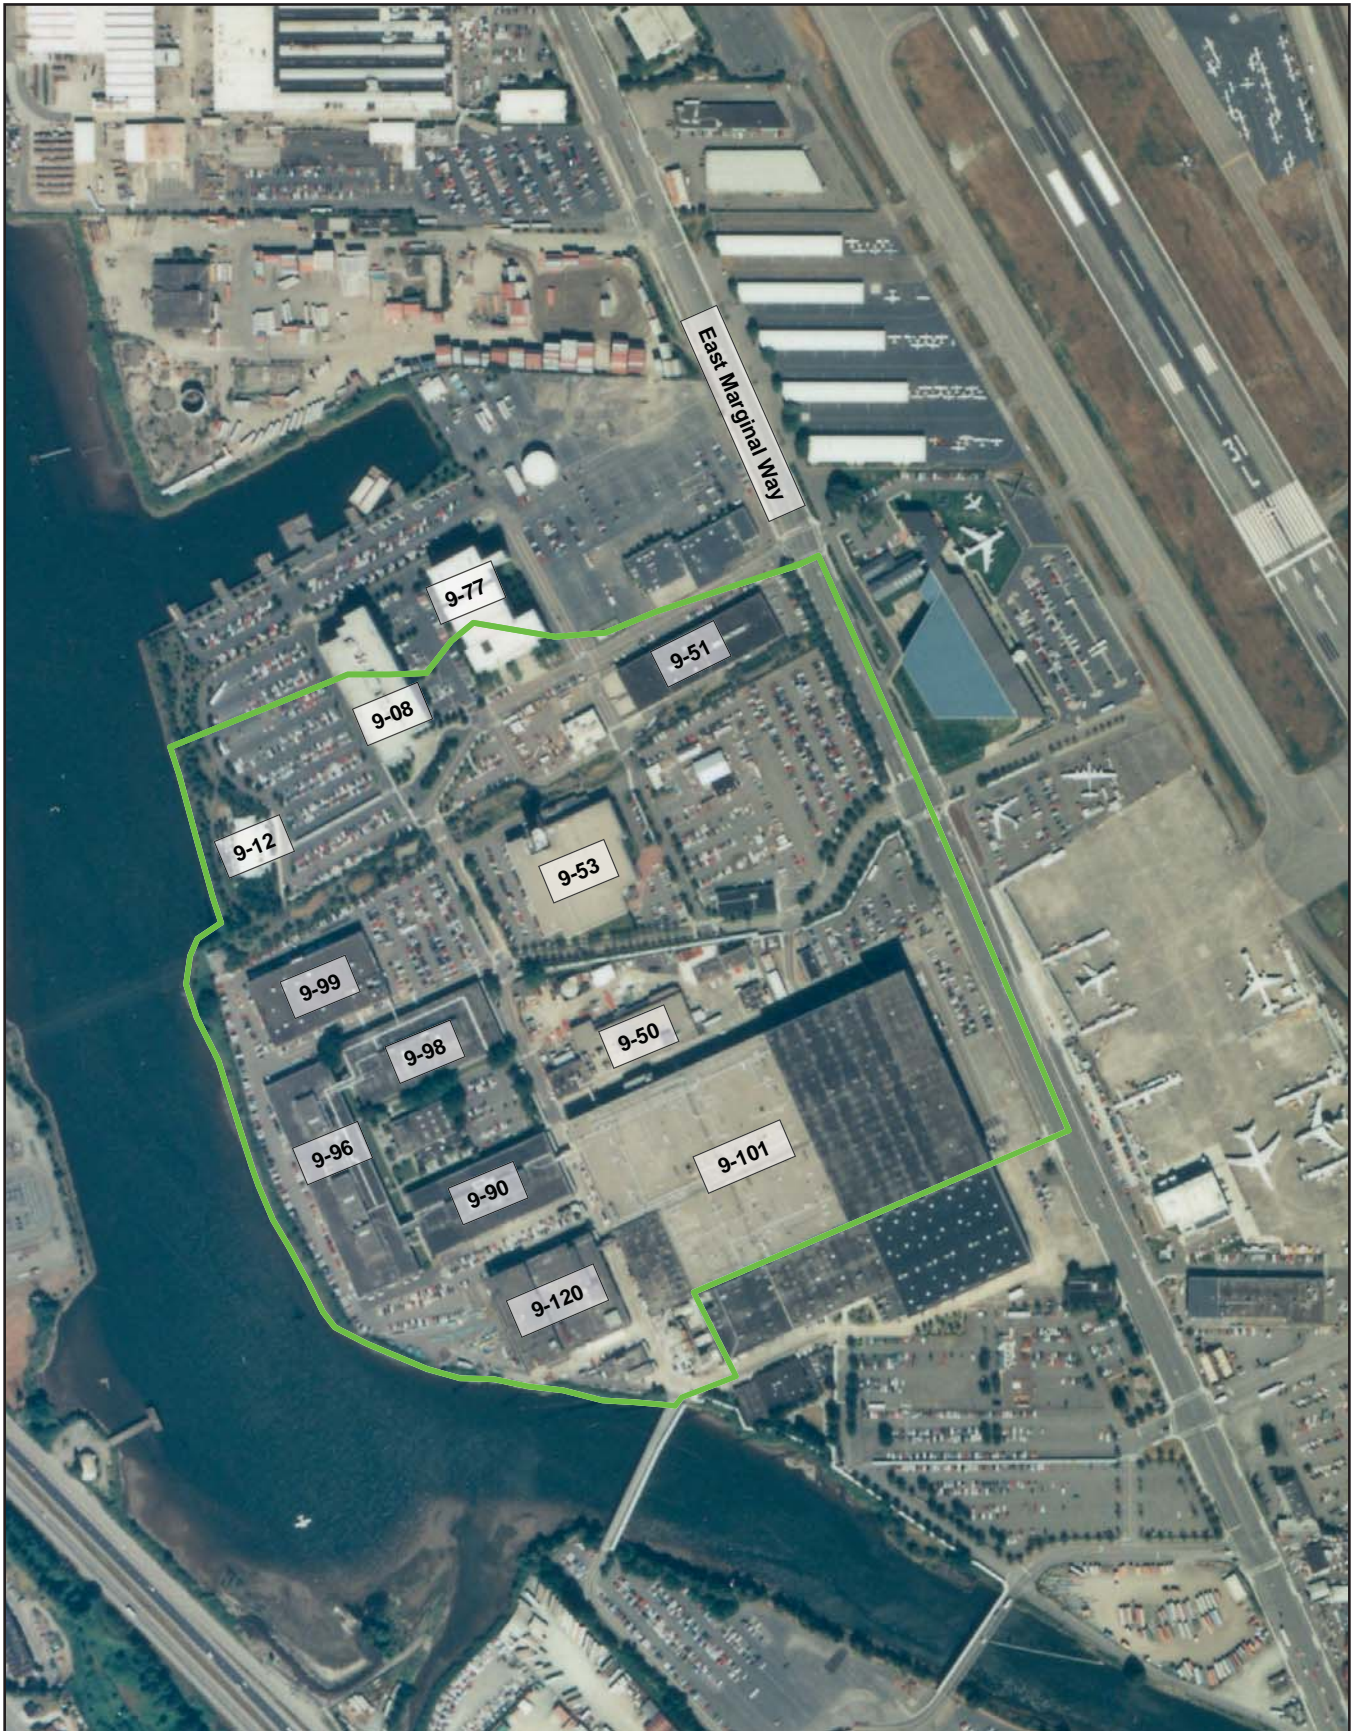
Figure B-9. RM 4.3-4.9 East
(Boeing Developmental Center): 1999

On the northwest section of the site, a portion of the parking lot closest to the LDW was reclaimed as natural area and Building 9-112 (the cafeteria) was constructed in 1991. According to King County tax records, this was the last building constructed on the BDC property. An unknown structure or structures can be seen on the north side of S 94th Place between the MOF and Building 9-77.

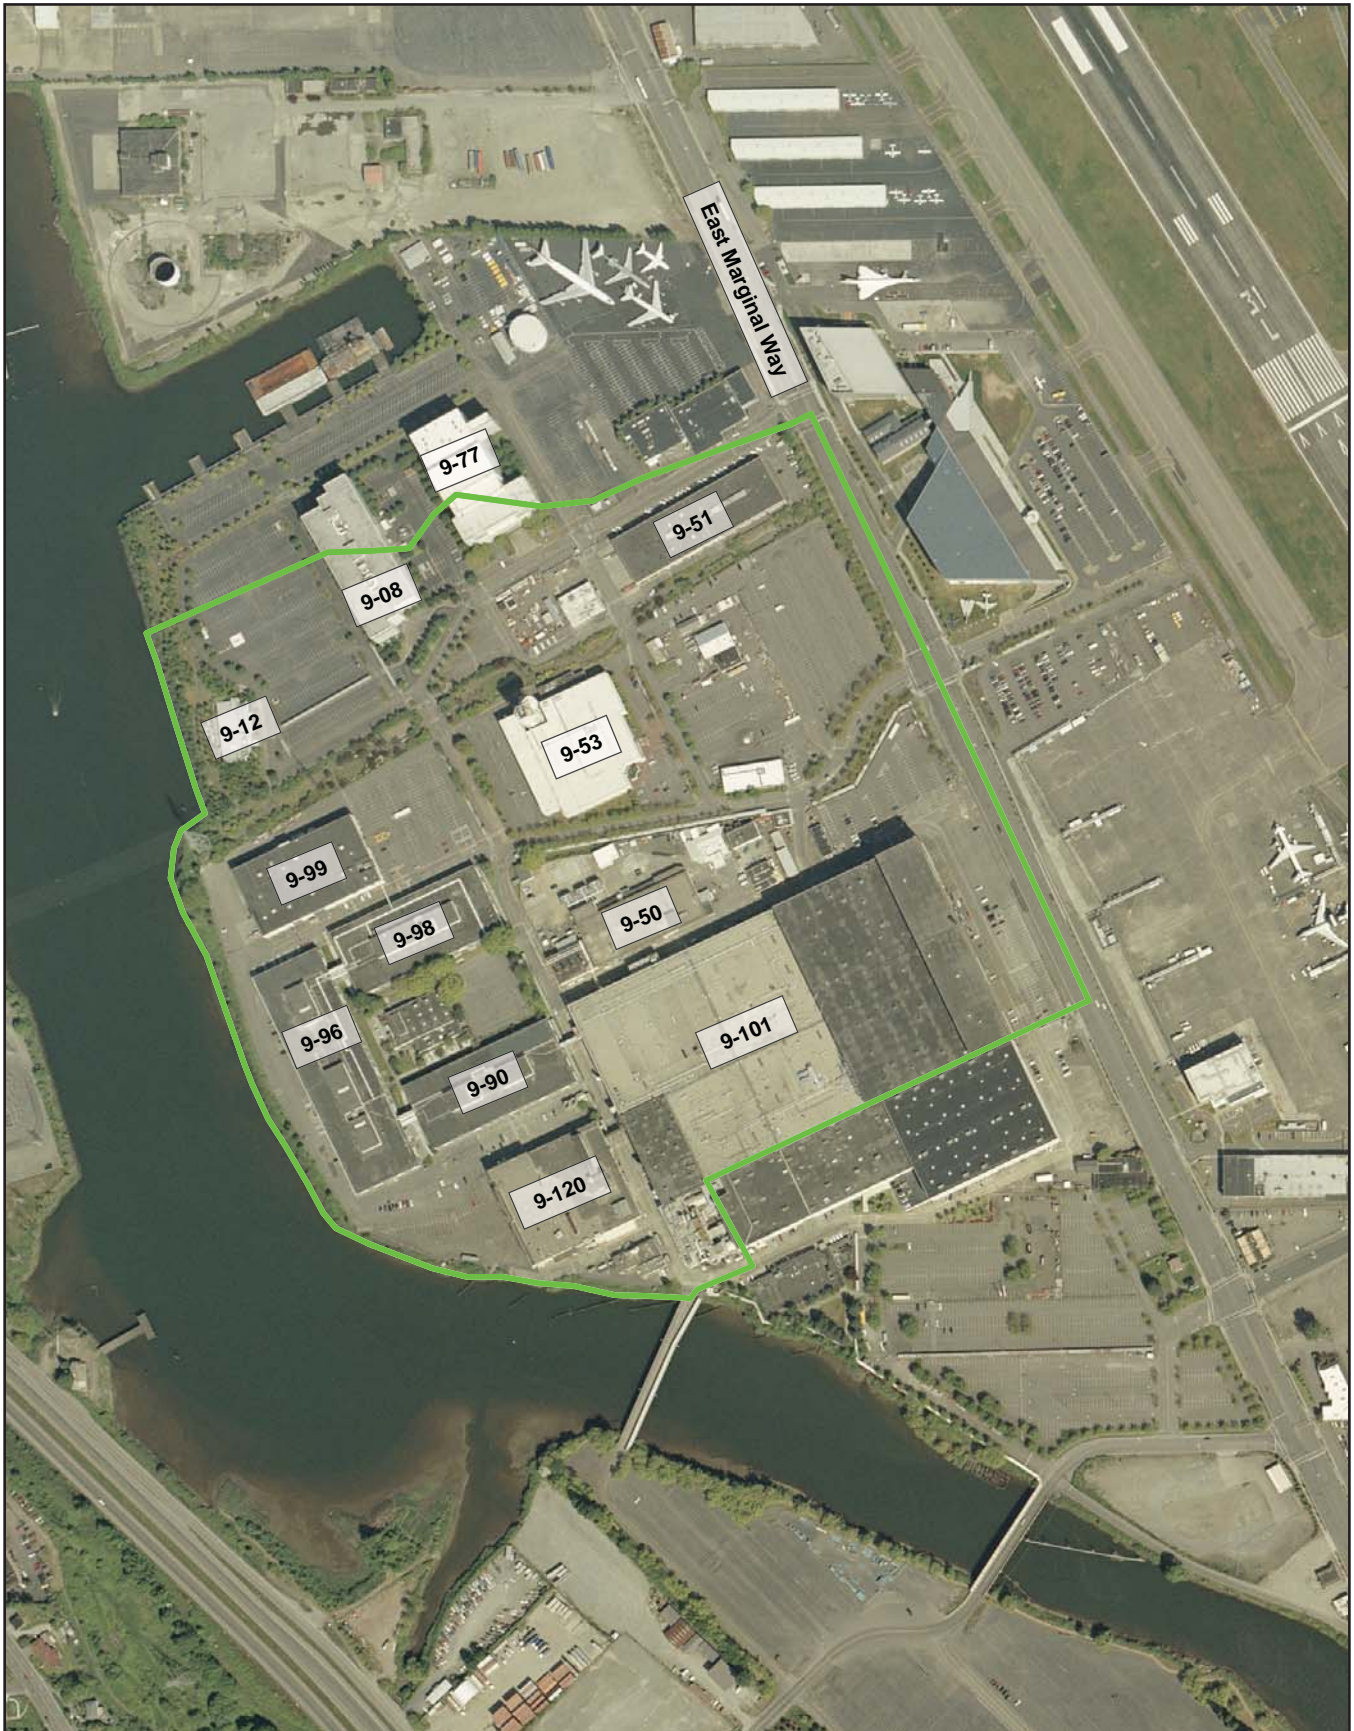
Figure B-10. RM 4.3-4.9 East
(Boeing Developmental Center): 2004

The only notable change between the 1999 and 2004 photographs is the addition of what might be three air venting structures on the north side of Building 9-50. All other structures and the shoreline appear similar.
